# **Biological Discipline Report**

Wetland Delineation, Mitigation, and Floodplain Habitat Assessment

NE 40<sup>th</sup> Street Stormwater Trunk Line Extension City of Redmond, Washington

File No. 0500-211-00

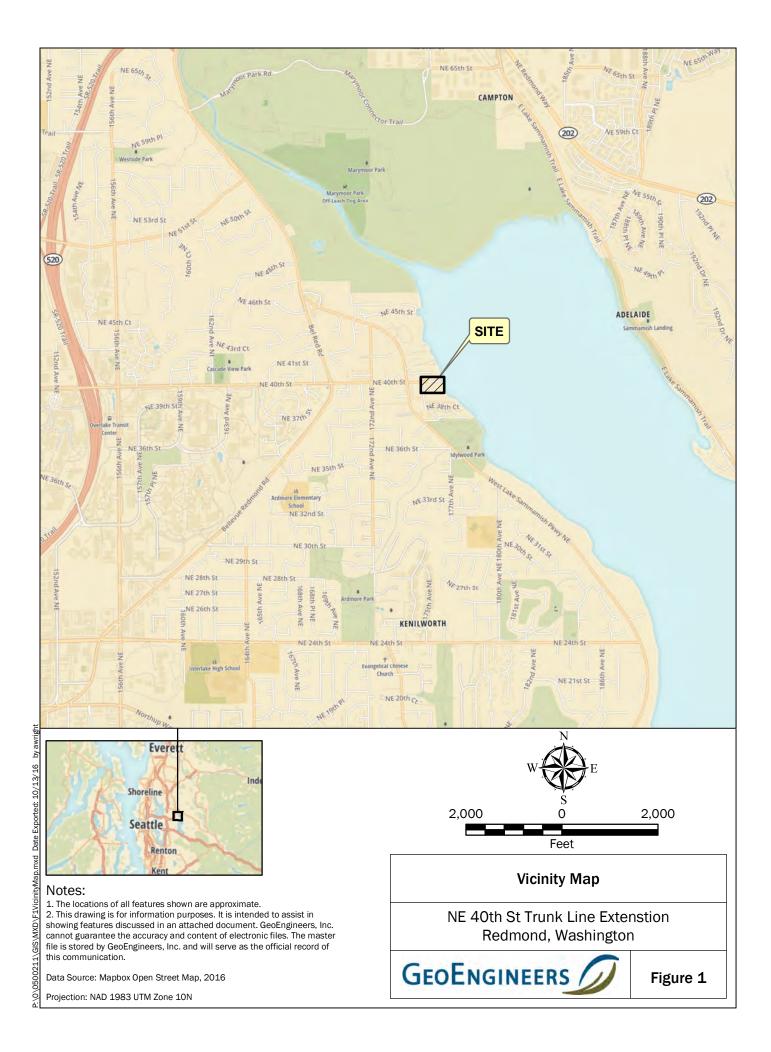
Figure 1. Vicinity Map

The project is located within the City of Redmond, near the northwest corner of Lake Sammamish (Figure 1, Vicinity Map). Preliminary design drawings developed by Coughlin Porter Lundeen (CPL) are included in Appendix A. The project will benefit local stormwater flow conditions, reducing peak flow volume and velocity at the system's existing outfall. Some water quality improvements are proposed as part of the construction plans, although the exact design and specifications of these features are not fully developed at this time. It is expected that this project will be designed and implemented to meet and receive certification as a "Salmonsafe" infrastructure development project.

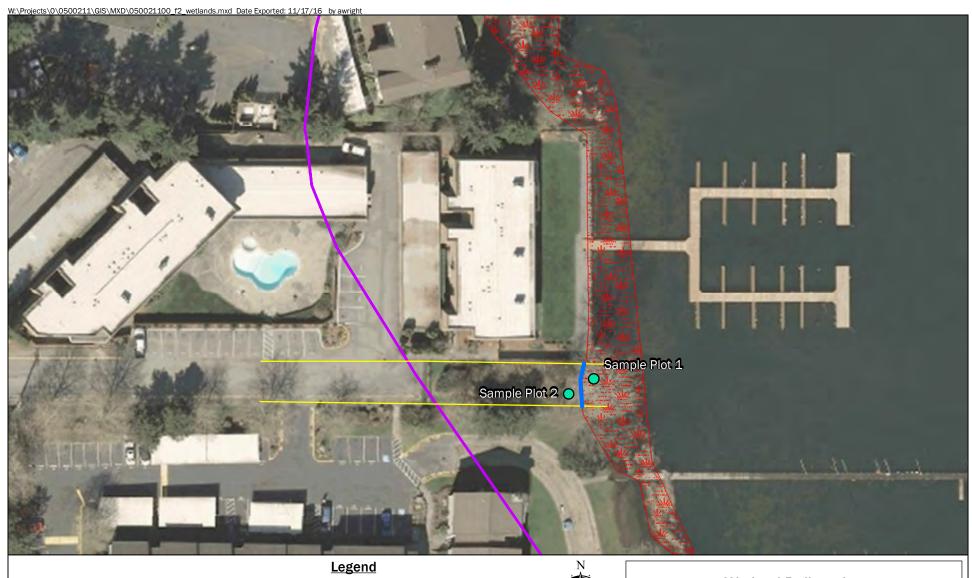
Figure 2. Wetland Delineation

The boundary of the wetland (Wetland A) within the City ROW is shown in Figure 2. Wetland A continues offsite to both the north and south of the site. The upland boundary on site was delineated along a topographic break with upland soils documented above and wetland soils below. Sample plot data sheets have been included in Appendix C.

FEMA floodplain maps show zone "AE" extending well above the lake OHWM at the project site (Figure 2). The design of this project places the proposed outfall structure within this area. Furthermore, as this project is located within 150' from the lake edge, it is located within the Protected Area Riparian Buffer Zone (RBZ). As such, the project has been designed to inherently avoid detrimental impacts without utilizing compensatory mitigation. Specific to potential flooding implications, this project will:

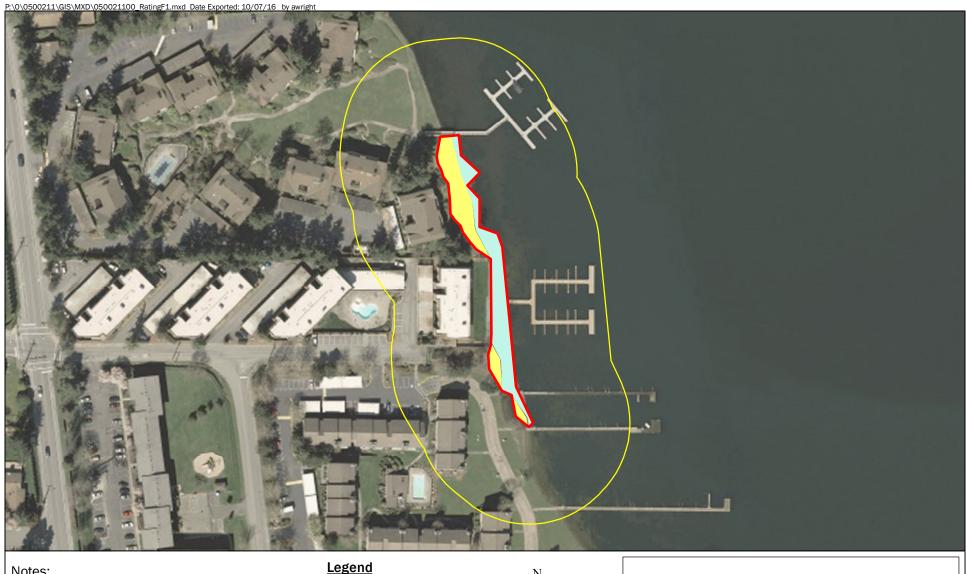
# Notes: 1. As the wetland features only emergent and aquatic bed cowardin classes, question L1.2 can be seen on this figure.

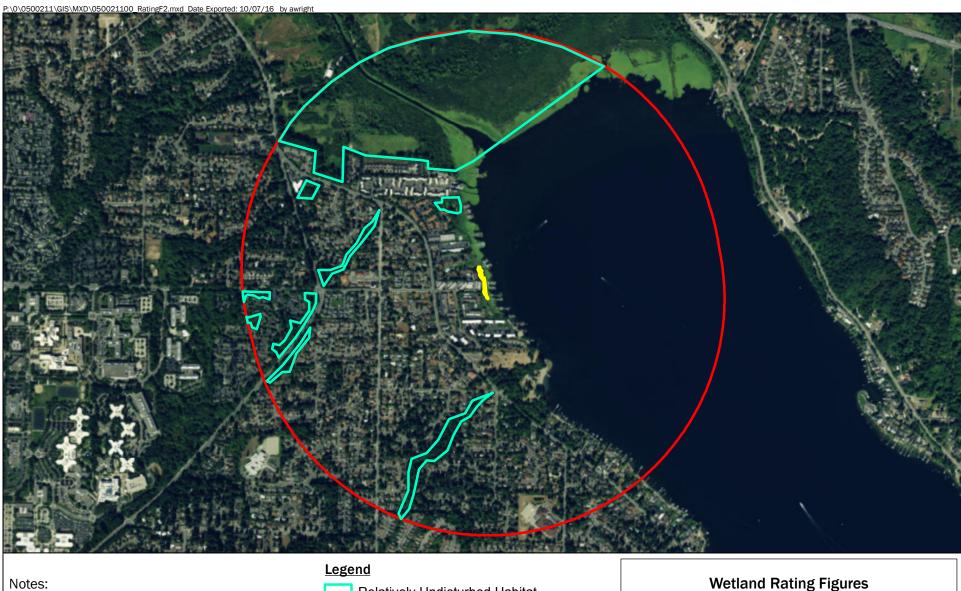
- 1. There is no accesible, relatively undisturbed habitat adjacent to the wetland. 2. The locations of all features shown are approximate.
- 3. This drawing is for information purposes. It is intended to assist in showing features discussed in an attached document. GeoEngineers, Inc. cannot guarantee the accuracy and content of electronic files. The master file is stored by GeoEngineers, Inc. and will serve as the official record of this communication.
